BRIDGE DECK - RINGGOLD, GA

PROJECT DESCRIPTION

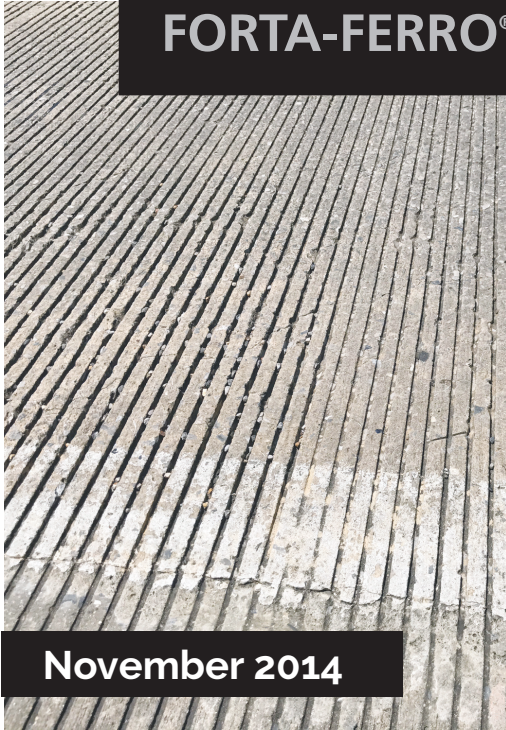
November 2014

FORTA-FERRO[®] was used in late 2001 on a state bridge deck topping project in Ringgold, GA. The bridge, originally built in 1950's, had been resurfaced in 1997, but had already deteriorated to the point of necessary repair. The Georgia D.O.T. looked to FORTA-FERRO[®] as an **easy-to-use and cost-effective method to add a high level of crack control and long-term durability**. After scarifying 3-1/2" of deteriorated concrete, a cement slurry was brushed on as a bonding agent, FORTA-FERRO[®] was added and mixed at a dosage of 4.0 lbs. / cu. yd. and then placed using a vibrating power screed. **FORTA-FERRO[®] offered no difficulties to the bull-float and broom finish.**

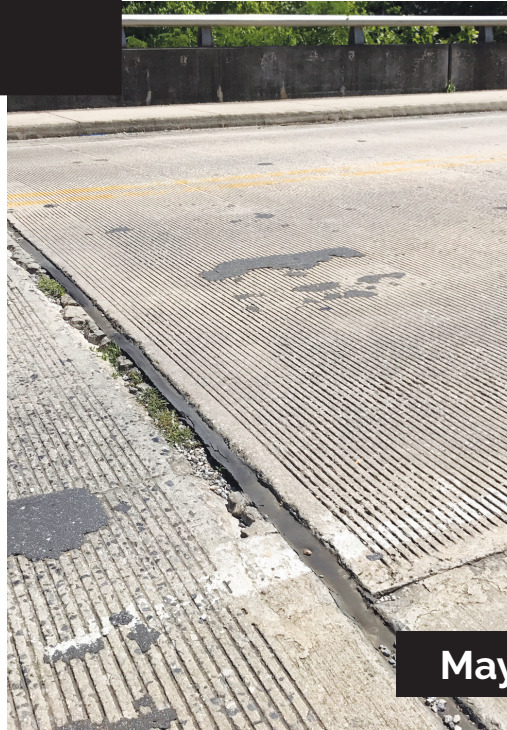
May 2017

The bridge deck was surveyed in May 2017, 16 years after the initial construction, and was found to **still be performing well under heavy impacts and traffic loads**. In the center picture above, you can see the ground base on the left (without FORTA-FERRO[®]) is deteriorating at a much faster rate than the flexing bridge topping slab on the right of the joint (reinforced with FORTA-FERRO[®]).
